SITE ASSESSMENT REPORT  
FOR  
HOFFMAN LANDFILL  
ROCKFALLS, WHITESIDE COUNTY, ILLINOIS  
TDD: T05-9308-023  
PAN: EIL0809SAA

NOVEMBER 15, 1993

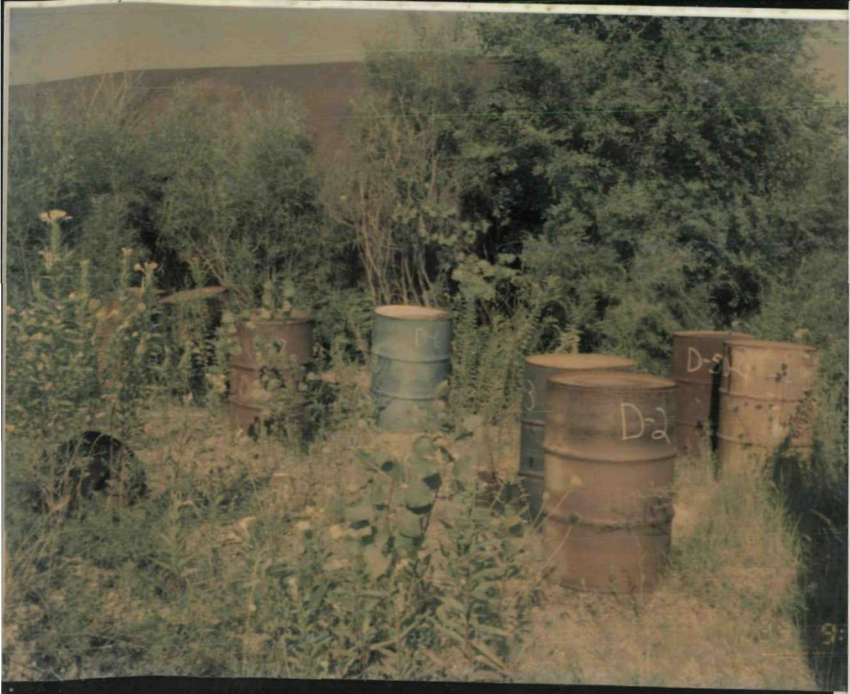
Site: Hoffman Landfill TDD:T05-9308-023 PAN:EIL0809SAA Dir: W  
 Date: 8/25/93 Time: 0918 Weather: Cloudy, 70°F Photo by: J. Sherrard  
 Comments: View of several 55-gallon metal drums found adjacent to Hoffman Landfill near Advanced Asphalt Company

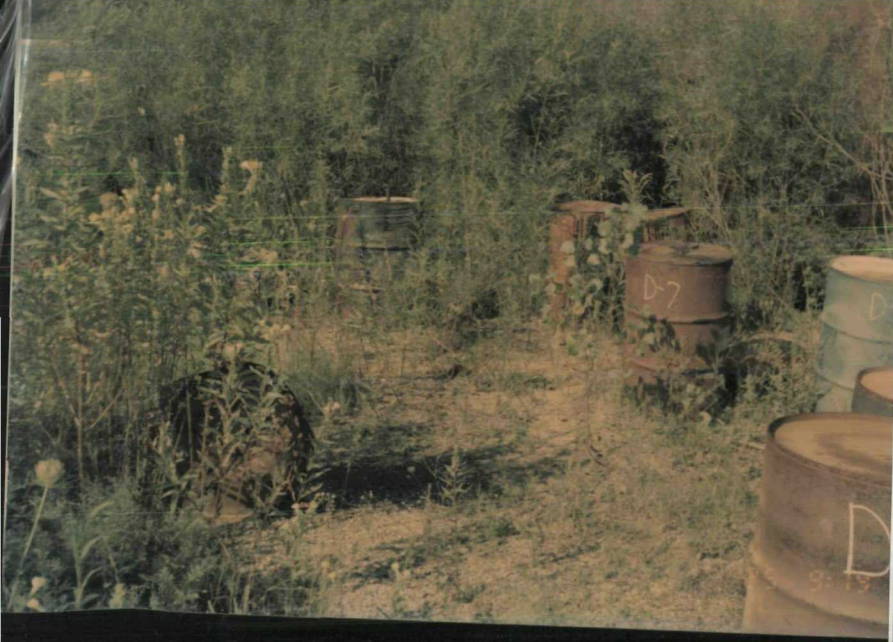
Site: Hoffman Landfill TDD:T05-9308-023 PAN:EIL0809SAA Dir: W  
 Date: 8/25/93 Time: 0919 Weather: Cloudy, 70°F Photo by: J. Sherrard  
 Comments: View of 55-gallon drums and the metal tank

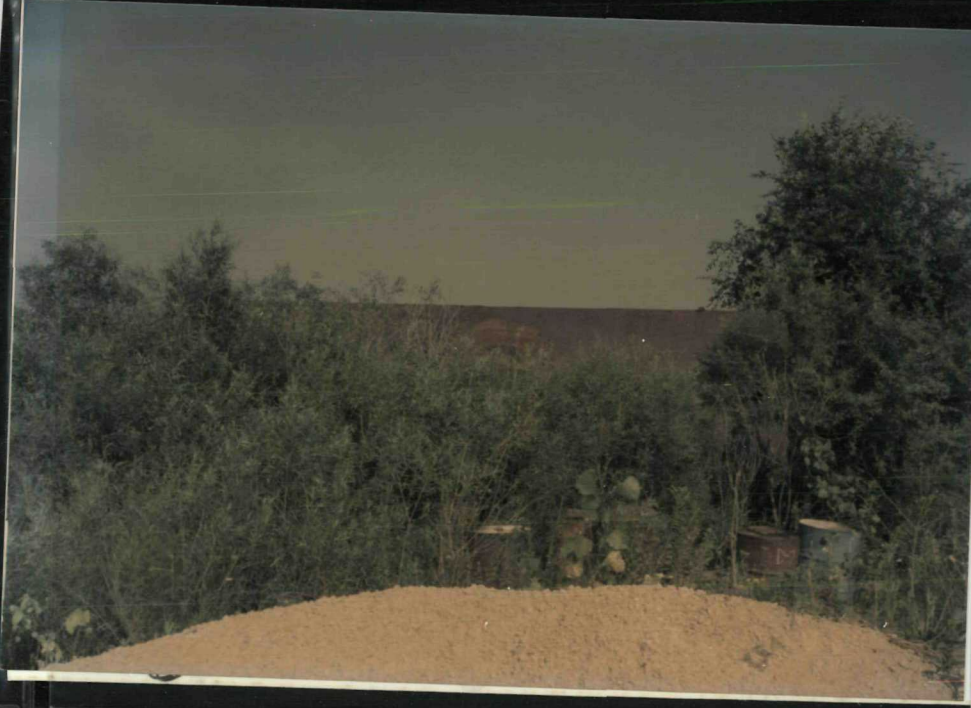
the northwest side of AAC (Tank#1) contained black asphalt-like material at its bottom. During this SA, TAT labelled all the twenty one (21) drums found on the location. Seven (7) of these drums contained small quantities of material while the rest of the fourteen (14) drums were observed to be empty. One of the seven drums had a label of hydraulic oil, while a second drum had a label of diesel oil. Bruins, per OSCs request, had agreed to reclaim these two drums. Bruins indicated that the two vertical tanks (mentioned previously) belonged to AAC. He had also informed the OSC that the horizontal tanks at this location were present from last 20 years. In close proximity to the two vertical tanks, twelve (12) black, 55-gallon metal drums and three (3) 30-gallon metal drums were present (Figure 2 - Site Features Map). These were identified by Bruins as belonging to AAC and provided the OSC with material safety data sheets (MSDS) of the drum contents. The MSDS information indicated that the drum material contained trichloroethane, perchloroethylene, and other solvents. PID reading on Tank#1 indicated 18 parts per million (ppm) of organic atmosphere. Another horizontal tank appeared empty but indicated a PID reading of 5 ppm.

After this site reconnaissance, TAT made preparations for sampling the drums. Most of the seven drums identified earlier appeared to contain small quantities of rain water mixed with oily material. Due to the nature of the drum contents and their volume, no samples were taken during this SA. Tank#1 sample could not be collected because of the small amount of material at its bottom.

Site: Hoffman Landfill TDD:T05-9308-023 PAN:EIL0809SAA Dir: W  
 Date: 8/25/93 Time: 0920 Weather: Cloudy, 70°F Photo by: J. Sherrard  
 Comments: Photo of tank T-1 surrounded by bushes. Tank T-1 had a small volume of black tar like material.

Based on drum and tank locations, and the similarity of drum and tank contents to AACs raw materials and product, OSC had requested Bruins to take actions to abate threats posed by the deteriorating tank and drums within ten (10) days. Bruins had indicated that they will empty Tank#1 and the seven drums and send them to a fuels blender.

This refers especially to the contents of the tank marked as T-1, and the drums marked D-1, D-4, D-5, D-6, D-7, D-10 and D-11. As well, the off spec material referred to as "tar binder" in the 12 55-gallon capacity drums would be moved to a location where they will not create a serious hazard to the environment from a potential release or be confused with hazardous waste materials.

1. All tanks and drums which contained fuel oil were pumped out by Safety Kleen Corp. of Elgin, Illinois.
2. All tanks and drums with the exception of one tank have been removed from our property and sold as scrap.
3. The drums containing an asphalt anti-strip additive have been grouped together and covered with a tarp. (See enclosed pictures.)

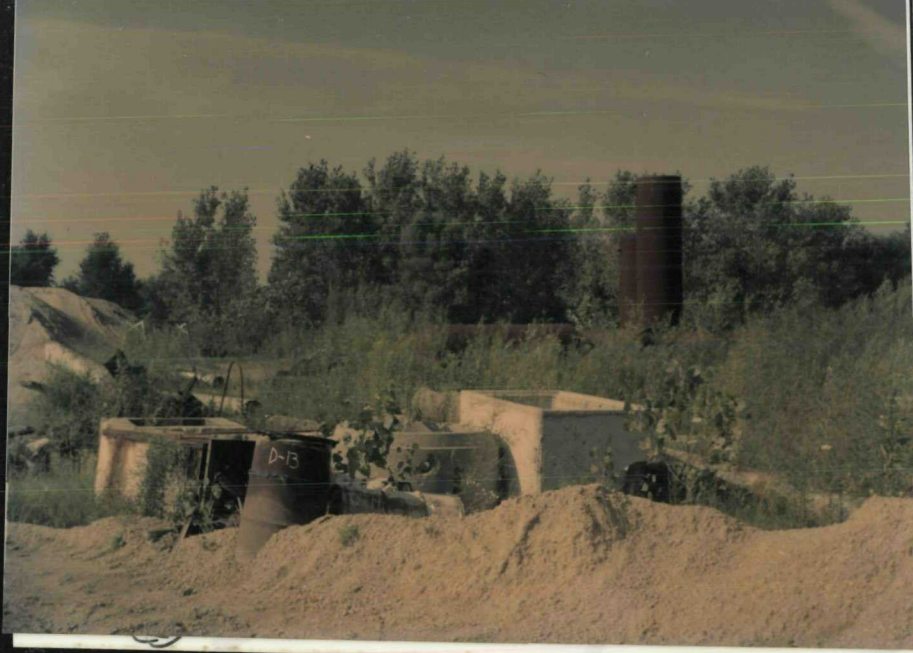
Site: Hoffman Landfill TDD:T05-9308-023 PAN:EIL0809SAA Dir: W  
 Date: 8/25/93 Time: 0922 Weather: Cloudy, 70°F Photo by: J. Sherrard  
 Comments: View of two vertical metal tanks that are used Advanced Asphalt Company for the manufacture of Asphalt.

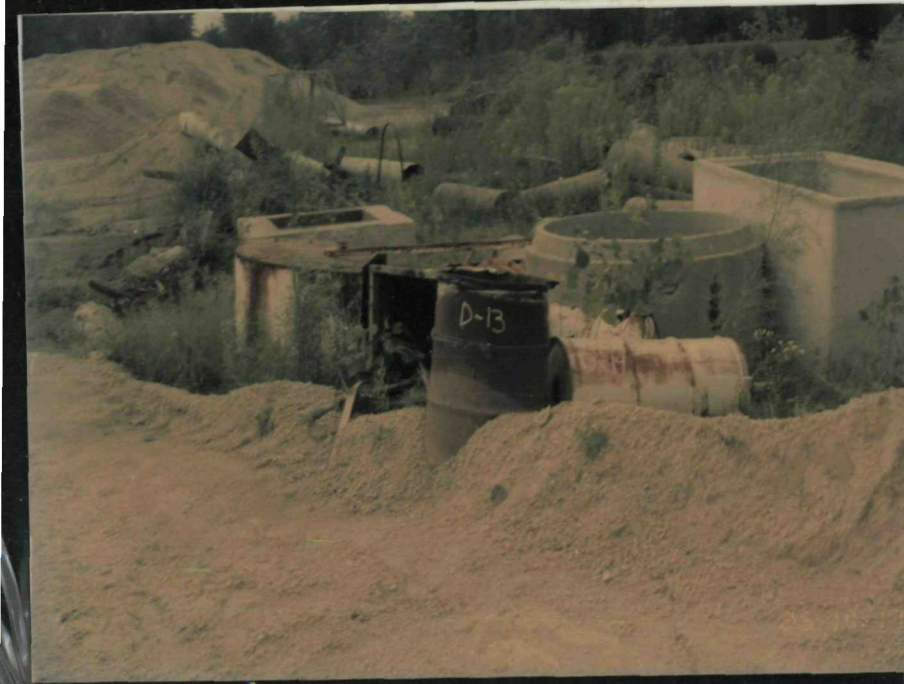
Site: Hoffman Landfill TDD:T05-9308-023 PAN:EIL0809SAA Dir: S  
 Date: 8/25/93 Time: 1117 Weather: Cloudy, 70°F Photo by: J. Sherrard  
 Comments: View of some empty 55-gallon drums located near Advanced Asphalt Company.

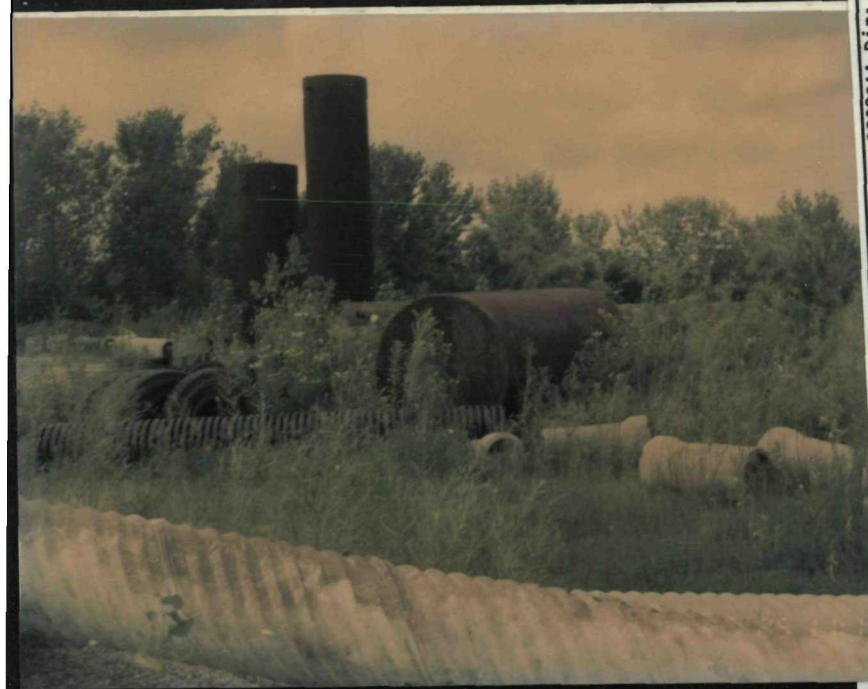
Site: Hoffman Landfill TDD:T05-9308-023 PAN:EIL0809SAA Dir: S  
 Date: 8/25/93 Time: 1117 Weather: Cloudy, 70°F Photo by: J. Sherrard  
 Comments: Photo of empty horizontal tanks and several pipes located near the two vertical tanks of Advanced Asphalt Co.

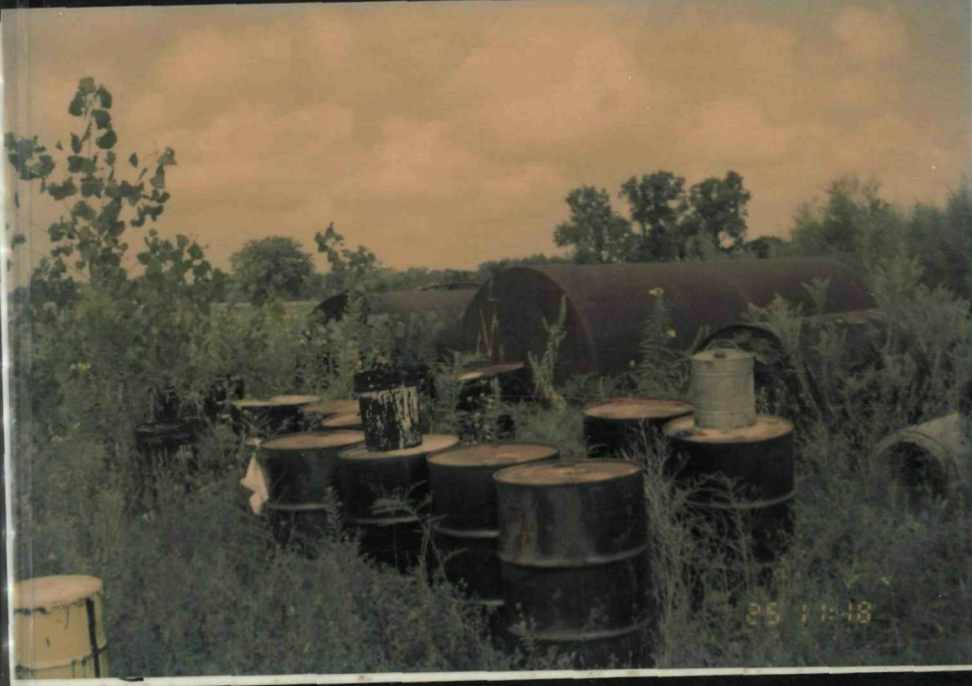
Site: Hoffman Landfill TDD:T05-9308-023 PAN:EIL0809SAA Dir: W  
 Date: 8/25/93 Time: 1118 Weather: Cloudy, 70°F Photo by: J. Sherrard  
 Comments: Photo showing twelve (12) black 55-gallon metal drums that appeared to have asphalt in them.

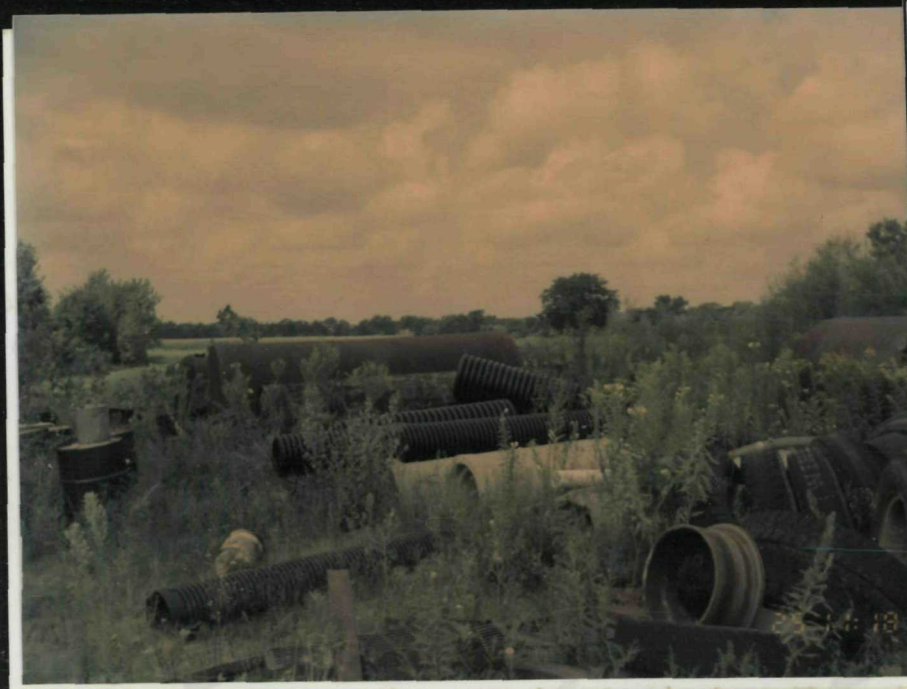
Site: Hoffman Landfill TDD:T05-9308-023 PAN:EIL0809SAA Dir: W  
 Date: 8/25/93 Time: 1118 Weather: Cloudy, 70°F Photo by: J. Sherrard  
 Comments: A closer view of four (4) horizontal tanks, several pipes, and tires located on the east side of Hoffman Landfill.

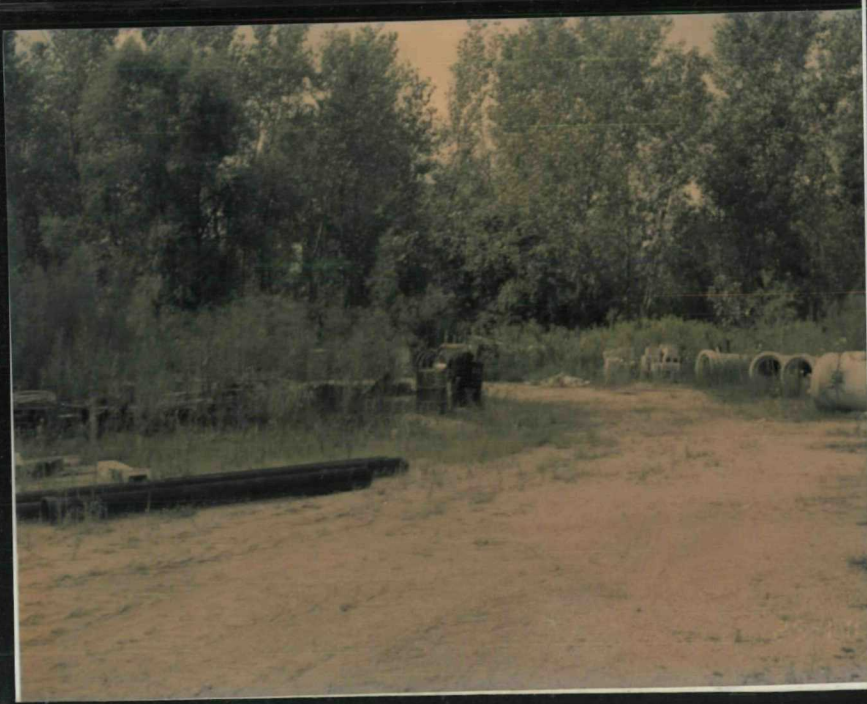
Site: Hoffman Landfill TDD: T05-9308-023 PAN: EIL0809SAA Dir: S  
 Date: 8/25/93 Time: 1118 Weather: Cloudy, 70°F Photo by: J. Sherrard  
 Comments: Photo of some more empty 55-gallon drums located south of vertical tanks.

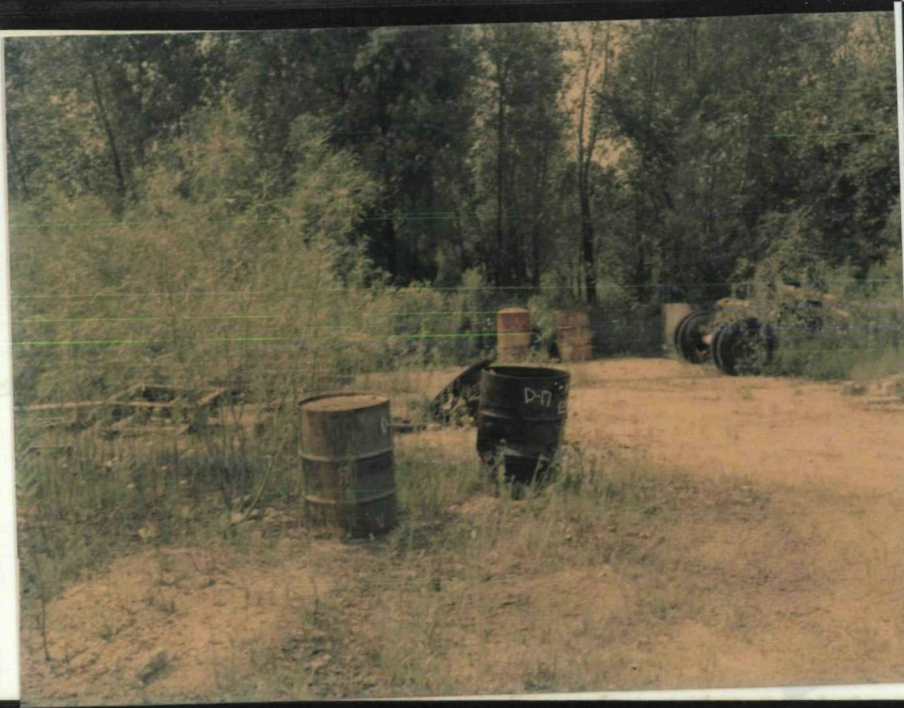
Site: Hoffman Landfill TDD: T05-9308-023 PAN: EIL0809SAA Dir: S  
 Date: 8/25/93 Time: 1119 Weather: Cloudy, 70°F Photo by: J. Sherrard  
 Comments: View of two orange/yellow metal 55-gallon drums labelled RC-70, that belong to Advanced Asphalt Company.

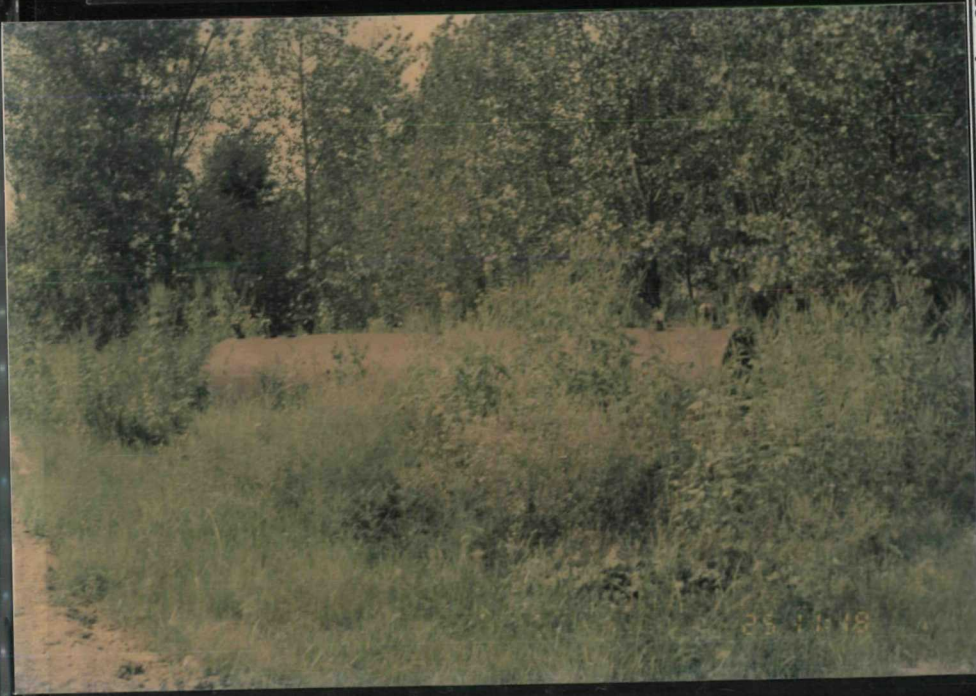
Site: Hoffman Landfill TDD: T05-9308-023 PAN: EIL0809SAA Dir: SE  
 Date: 8/25/93 Time: 1119 Weather: Cloudy, 70°F Photo by: J. Sherrard  
 Comments: Photo of an empty horizontal tank located in the bushes of Advanced Asphalt Company.

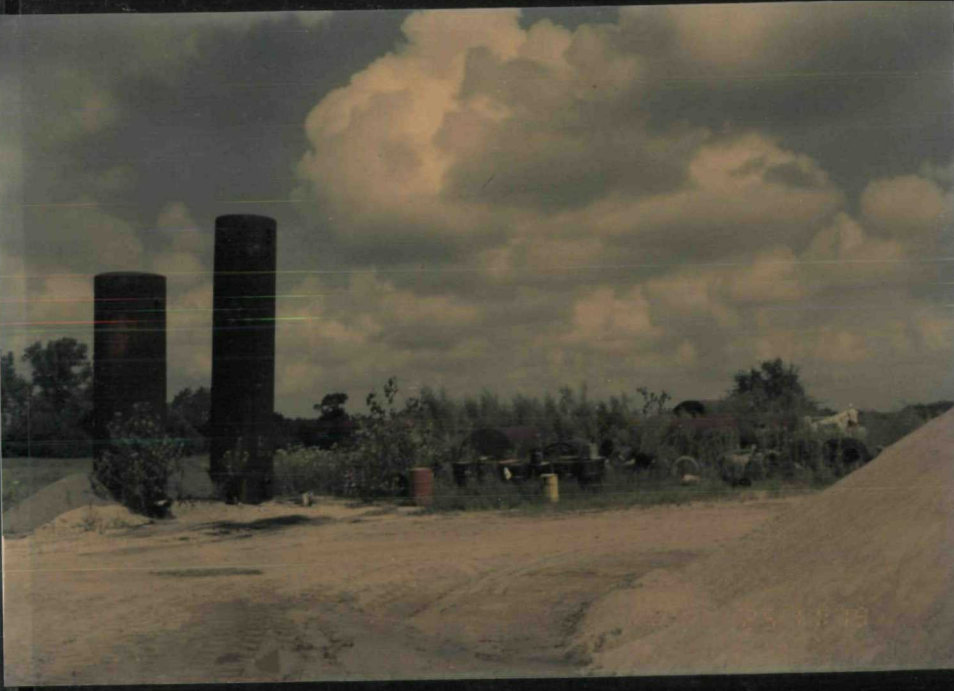
Site: Hoffman Landfill TDD: T05-9308-023 PAN: EIL0809SAA Dir: S  
 Date: 8/25/93 Time: 1119 Weather: Cloudy, 70°F Photo by: J. Sherrard  
 Comments: A perspective of tanks and drums located outside the eastern boundary of Hoffman Landfill.

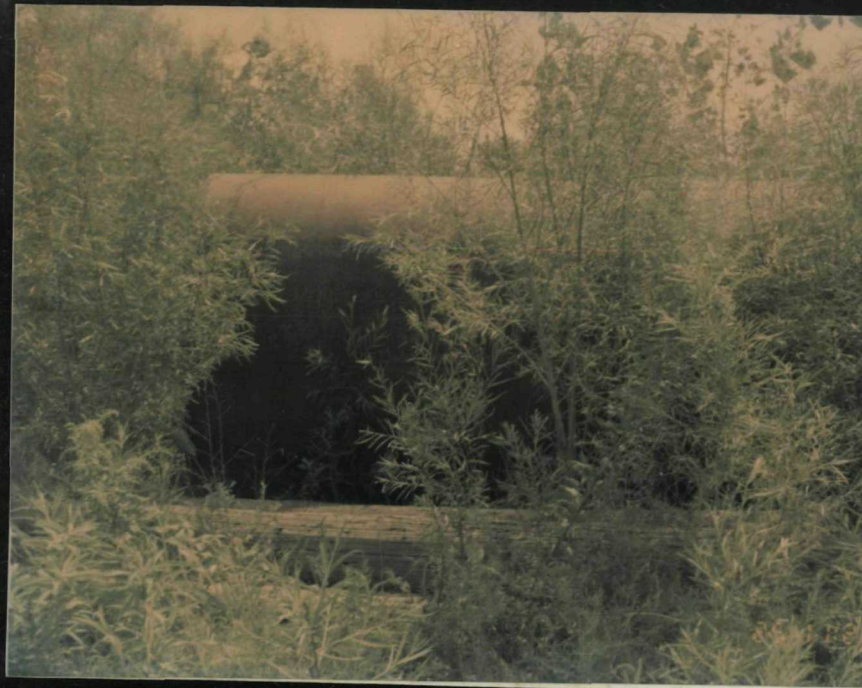
(11)

Site: Hoffman Landfill TDD:T05-9308-023 PAN:EIL0809SAA Dir: E  
 Date:8/25/93 Time:1120 Weather:Cloudy, 70°F Photo by:J.Sherrard  
 Comments: View of an horizontal tank located in the bushes of  
 Advanced Asphalt Company premises.

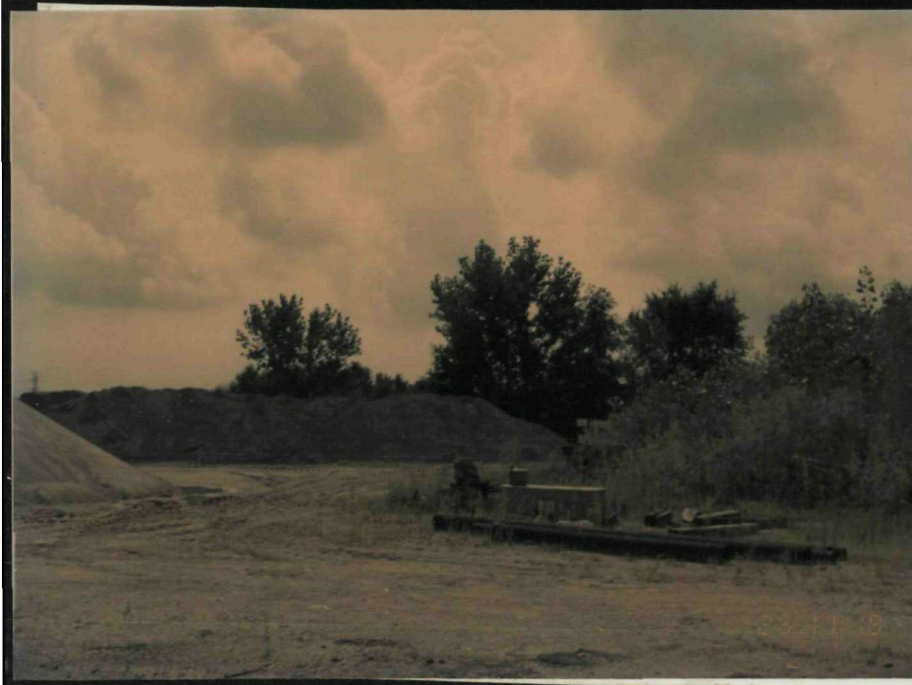
(12)

Site:Hoffman Landfill TDD:T05-9308-023 PAN:EIL0809SAA Dir: S  
 Date:8/25/93 Time:1119 Weather:Cloudy, 70°F Photo by:J.Sherrard  
 Comments: Sand other material located on Advanced Asphalt  
 Company premises, that is used for asphalt manufacture.
